Shelter working group

Field assessment report: Maniche: Sud department

Timber salvage

Date: 12/11/2016

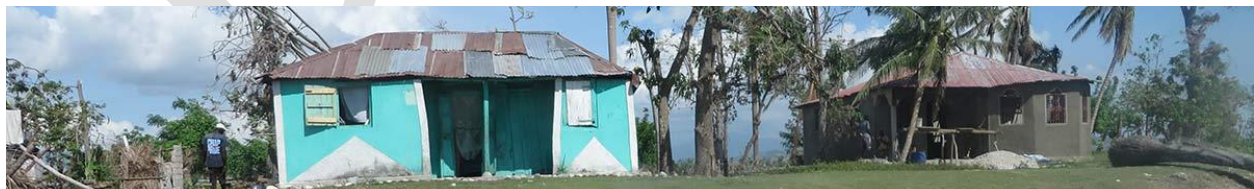
- Self driven recovery is ongoing in earnest.
- 10-20% of observed houses had one or more new CGI sheets on the roof.
- Several people said that they would prefer to rebuild houses with blocks and that molds for forming blocks were available.
- Everyone people were salvaging materials from their houses

Photo: People are rebuilding wherever possible. The building pictured here has a roof repaired with a combination of salvaged and new corrugated iron

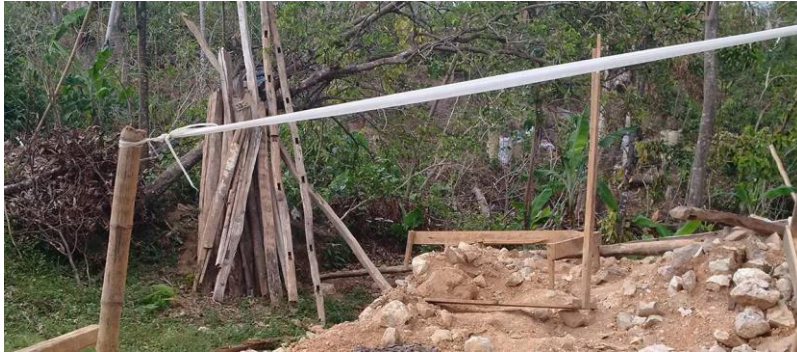
- A lot of the timber in houses were old, had infestations in the structural members, had rot where the wood was in contact with the ground or had been structurally weakened with notches and previous construction.
- Most of the timber seemed to have broken at the joints (nails pulling out, etc.) rather than splitting in two.
- Not all of timber could re-usable and most had limitations for structural uses.

Photo: The home owner has salvaged usable timber and other materials. However, the salvaged timber is often old, and has some damage from water, insects and previous construction markings

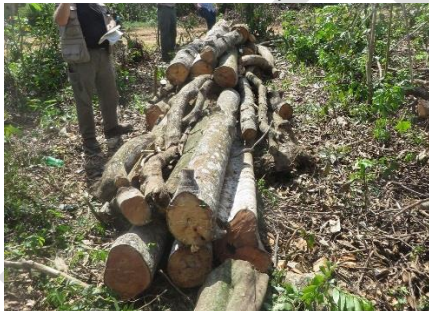
- Some larger fallen trees were being used for making charcoal because the wood was not appropriate for planks.
- Most charcoal production seems to be sold rather than stocked.

Photo: Wood stacked for making charcoal. The quality and species of the timber is not suitable for construction

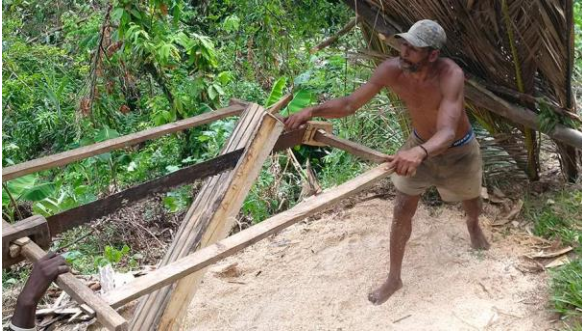
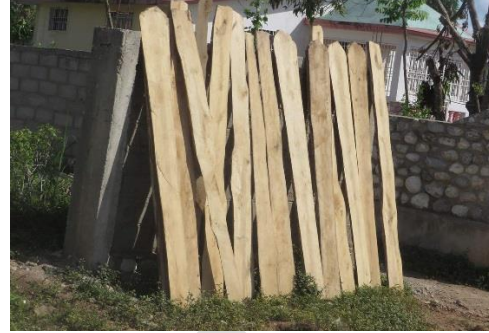
- Some timber is being sawn by hand and made into planks, but the limiting factor on the speed of plank production is skilled people with the tools to do it.
- Those making planks were planning to stock the some planks rather than sending them to market.
- The fallen timber to be used for planks should be sawn in months rather than years. Those sawing the planks prefer to use wet timber rather than dry timber, because it saws easier.
- Most of the fallen timber cannot be used for planks.
- Planks are primarily for use in furniture production.

- Planks are not generally used for structural purposes

Photo: Fallen trees of suitable species and quality are sawn into planks by hand, often on site. The primary use for this timber is furniture. There is a shortage of skilled workers able to make these planks

- There is **limited number of skilled workers to recover timber for boards**, but these are primarily used for furniture and not construction.
- Any IEC materials should reflect the reality of bush poles in construction, but **should not promote the use of locally sourced timber**

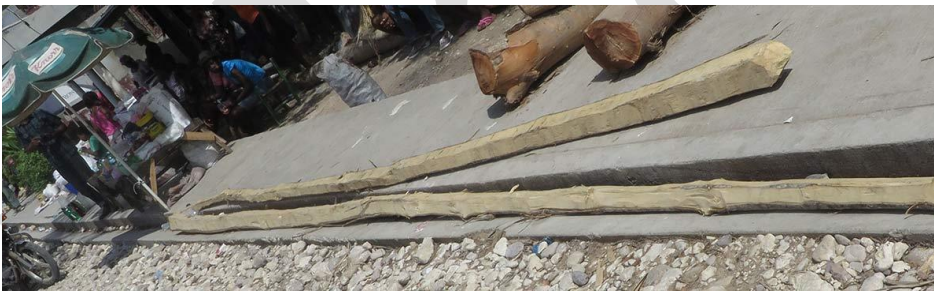
- There are limited volumes of timber suitable for structural purposes
- Planks are generally not used for Structural elements
- Bush Poles were being collected (8ft long approx 3" diameter) - it was not clear if all was from fallen timber. Some is still being cut for this purpose. These poles are used in housebuilding, bracing and scaffolding. They are cleaned by machete.
- Larger section timbers (greater than 3" section) do not appear to be salvagable in significant quantities.
- Difference in prices for poles were noted. In non-representative sampling, in a rural areas 12 poles were 200gd, in urban areas (les cayes) the same poles would cost 600gd
- There is a difference between access to materials in rural and urban areas – in rural areas it is possible to harvest and salvage some timber. In urban areas homeowners have to purchase all timber.

Photo: There appears to be very limited volumes of larger dimension of timber salvagable for construction purposes. All sawn 2x4 timber observed was imported.

- **Larger dimension construction timber needs to be imported** from outside the area as it does not appear to be available from salvaged timber in sufficient volume for the reconstruction.
